# SERVICE INFORMATION

## STANDARD AND TRIUMPH VEHICLES

<b>No.</b>	SPORTS/2/M	FLASHING SIGNAL LIGHTS	<b>Date</b>	FEBRUARY 1954
------------	------------	------------------------	-------------	---------------

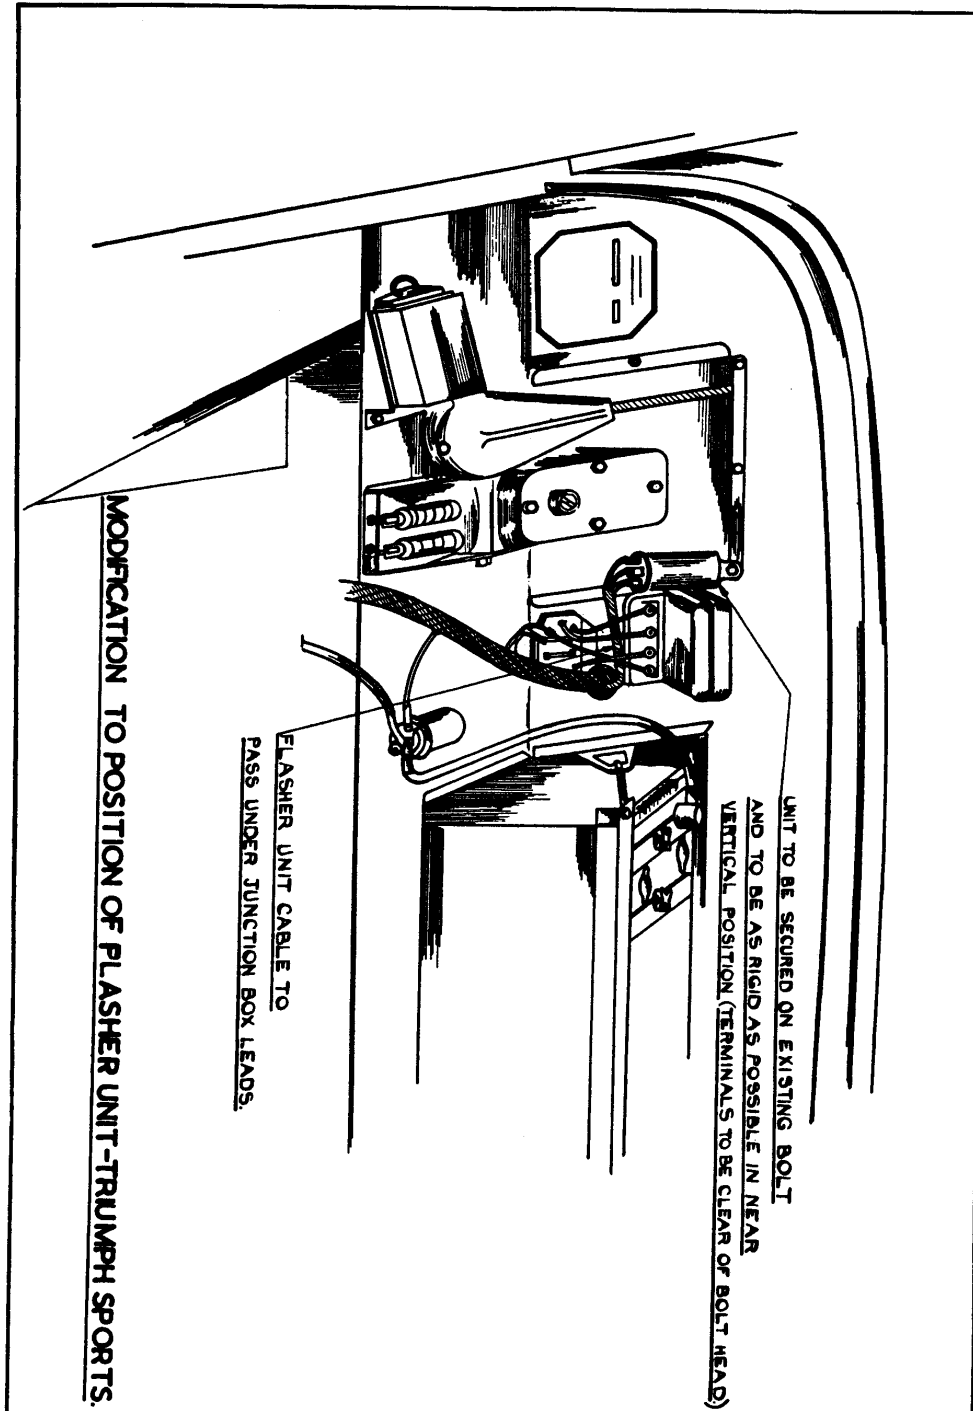
This vehicle is fitted with flashing type indicator lights and trouble has been experienced with the failure of the flasher control unit, Part No.107594.

This unit has been fitted horizontally and investigation by Messrs. Lucas has shown that the heat given off by the resistance is affecting the hinge of the contact strip, causing distortion and incorrect operation.

This unit is now fitted vertically (terminals pointing down the scuttle panel) and any replacement units must be fitted in this manner. It is possible to do this without modifying fixing bolts or harness and the latest position is shown in the illustration.
