SERVICE INFORMATION

STANDARD AND TRIUMPH VEHICLES

No.	SPORTS/2/E	JUMPING OUT OF SECOND GEAR	Date	APRIL 1954
------------	------------	----------------------------	-------------	------------

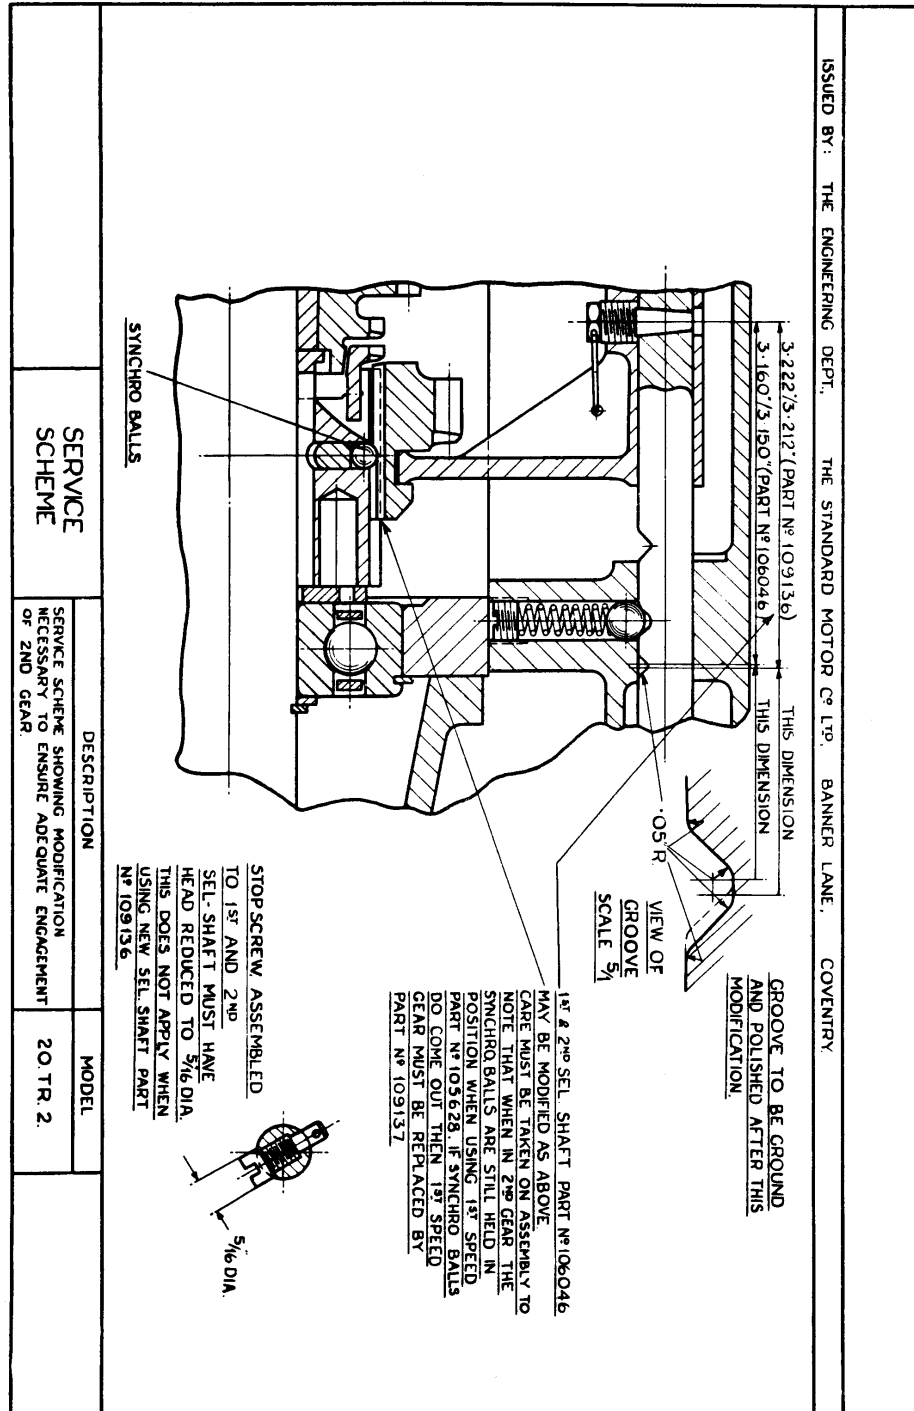
1 ILLUSTRATION

On earlier gearboxes it was possible, with certain combinations of limits, to have inadequate engagement on the flank of the dog teeth. This condition, apart from the crushing and bruising, owing to the small bearing area which permitted overdrive load to be carried on all dog teeth, allowed the gear to slip out when subjected to any appreciable over-run load.

Increased depth of gear engagement has been obtained by a modified selector shaft, Part No. 109136, with an altered locating groove, but the original selector rod, Part No. 106046, may be modified as shown in the illustration.
