SERVICE INFORMATION

STANDARD AND TRIUMPH VEHICLES

No.	SPORTS/4/G	FRONT SUSPENSION – TRUNNION FOR VERTICAL LINK AND LOWER WISHBONES	Date	AUGUST 1954
------------	------------	--	-------------	-------------

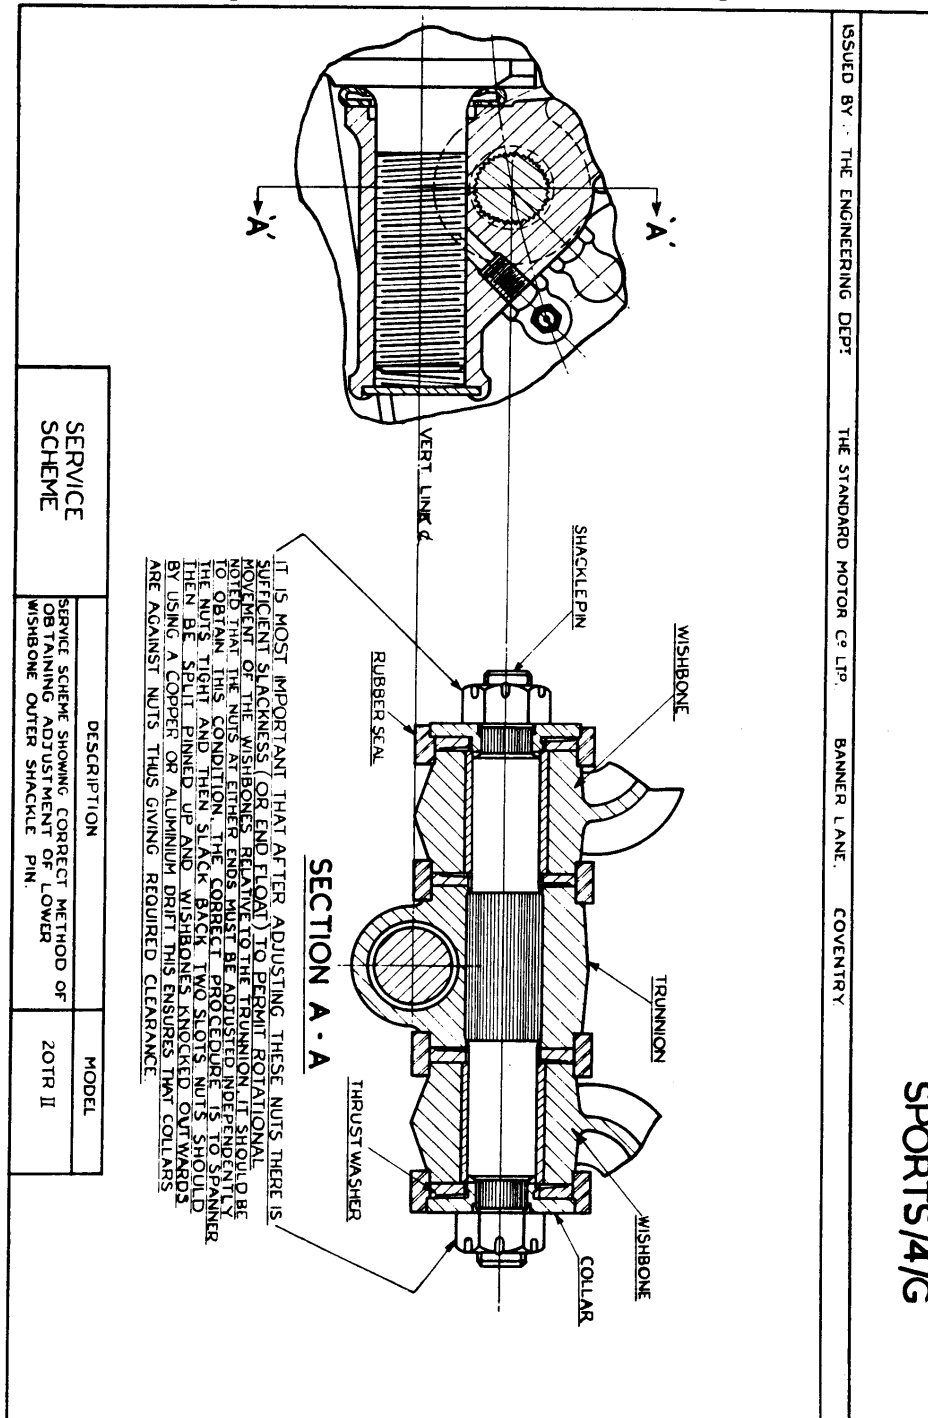
1 ILLUSTRATION.

Two cases of fracture of the screwed portion of the vertical link have been reported, which have been caused by over-tightening the outer wishbone pivots. This over-tightening permits severe bending to take place in the vertical link and resulted, in one case, in failure within 5 miles running.

The construction of this pivot is shown in the illustration and it is essential to have .004" - .012" end float for the boss of each wishbone arm. It will not be possible to measure this float owing to the grease retaining seals and the following procedure must be regarded:

- (a) The pivot pin should be chocked for centralisation in the bronze trunnion. This pivot pin is a press fit in the trunnion, located in the bronze against turning by self-cutting splines and may be centralised by the use of a press or a suitable soft metal drift.

- (b) The parts should be assembled as shown in the drawing and tightened up equally on each nut to prevent alteration of the relation of the pivot with the bronze trunnion. The outer washer is also located against radial movement by self-cutting splines on the pivot pin and equal tightening should be continued until the assembly is solid.

- (c) The nuts should next be slackened back 1/2 to 1-1/2 flats and then split-pinned. The wishbone arms should then be lightly tapped outwards to displace the splined outer washers and here again this should be carried out alternatively on each arm to avoid altering the relationship of the pivot and the trunnion.

- (d) This should give the recommended clearance to the bushes, but as a final precaution the assembly should be checked for freedom of movement over its full range of operation before fitting the road spring.

This need for adjustment should only occur when the front suspension is disturbed but as a precautionary measure any possibility of tightness at this point should be checked during normal routine maintenance.
