# SERVICE INFORMATION

## STANDARD AND TRIUMPH VEHICLES

<b>No.</b>	SPORTS/1/P	ADJUSTMENTS AND MAINTENANCE OF S.U. CARBURETTOR TYPE H.4	<b>Date</b>	AUGUST 1954
------------	------------	---	-------------	-------------

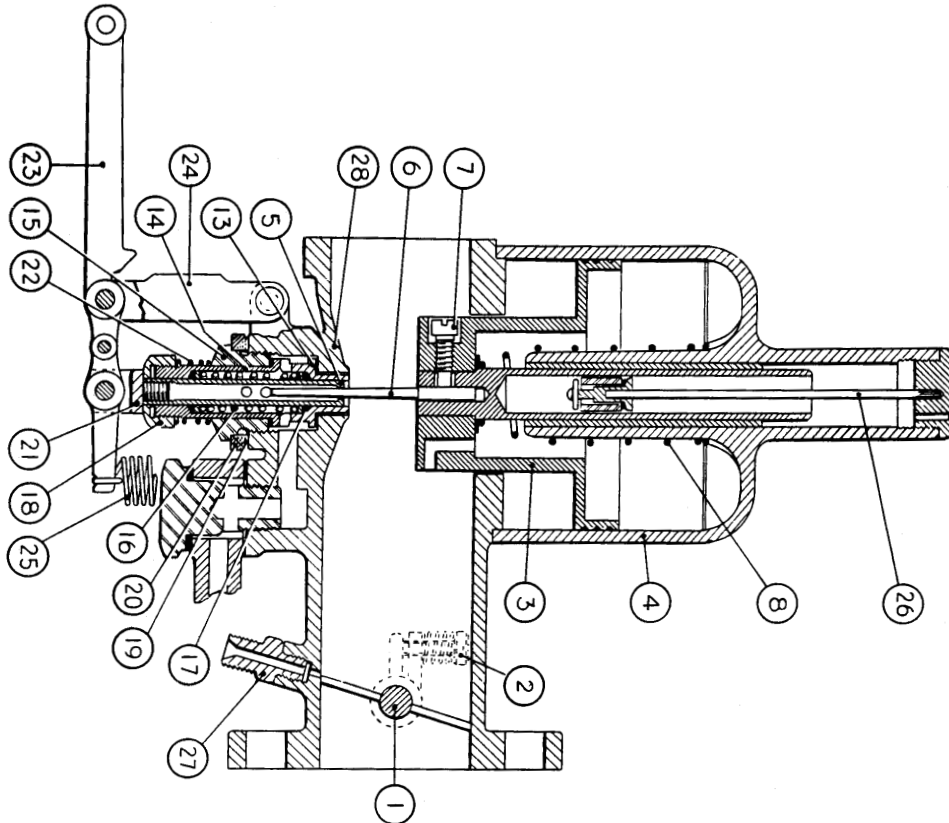
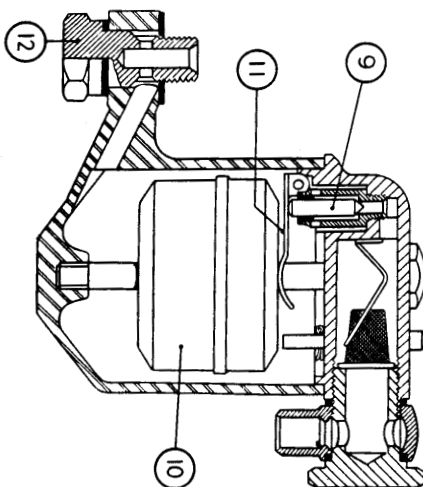
The suction chamber (4) and piston (3) should be removed and the jet needle (6) position checked. The needle shoulder, as shown in the illustration, should be flush with the base of the recess in the piston.

The shoulder of the needle should be flush with the shoulder of the needle seat. The correct datum point for each is shown.

This should be carried out by removing the suction chamber (4), piston (3), and replacing the needle (6) in its socket. The needle is located by the clamping screw (7). It is most important that the location of the jet needle in the piston is correct as shown in the illustration and the paragraph on 'Carburettor Tuning,' and also that the jet needle is checked for eccentricity and altered if necessary as shown in the Paragraph on "Carburation Defects.'
