SERVICE INFORMATION

STANDARD AND TRIUMPH VEHICLES

No.	SPORTS/16/R	SERVICING OF BRAKE DISC T.R.3 Only	Date	MAY 1958
------------	-------------	---------------------------------------	-------------	----------

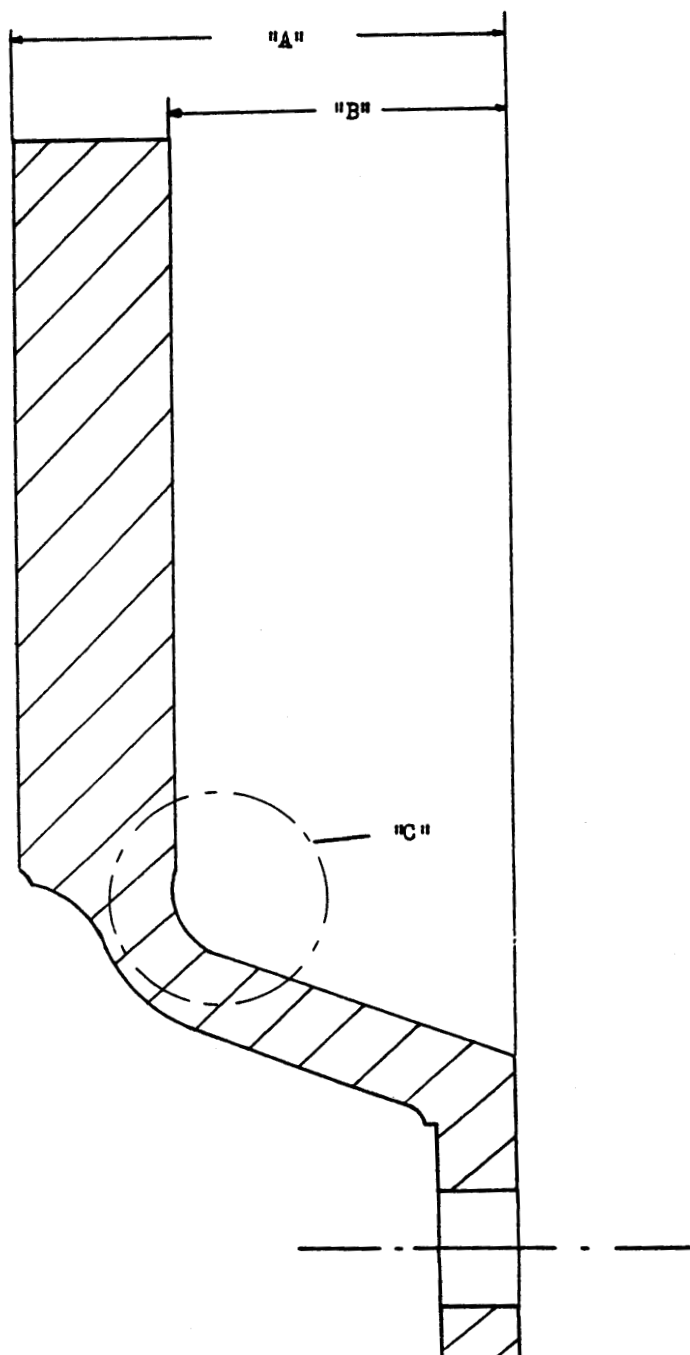
It is unlikely that the brake disc will ever require attention, but should it ever suffer damage or be excessively scored, Messrs. Girling Limited and ourselves recommend that it be replaced with a new disc. If, however, replacement of the disc is not possible and regrinding is contemplated, great care should be exercised, as incorrect grinding can seriously mar the efficiency of the brake. It is a skilled operation and should only be undertaken by competent engineers.

The machining limits shown below should not be exceeded under any circumstances. The maximum that can be removed from either side of the disc is .025" (.63 mm) and, as illustrated overleaf, measurement "A" should not be LESS than 1.475" (37.46 mm) and measurement "B" should not be more than 1.025" (26 mm). The ground surface should be flat and parallel to the mounting face with a fine finish, taking special care that the grinding of the inside face of the disc is "blended" at point "C".
