TECHNICAL SERVICE BULLETIN

Triumph

CRANKSHAFT SPIGOT BUSH SQUEAL

TR7

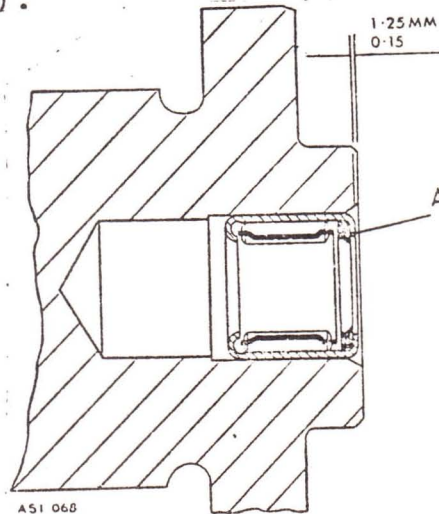
In the event that a TR7 owner should complain of a squealing noise emanating from the spigot bush in the rear of the crankshaft on 1975 and 1976 TR7s, this can be overcome by the installation of a needle roller bearing, part #UKC-8154 in place of the bronze spigot bush. (Refer to diagram).

1. Remove the gearbox.
2. Remove the clutch assembly.
3. Remove the 8 flywheel retaining bolts.
4. Remove the spigot bush retaining plate and discard.
5. Withdraw the spigot bush and discard.
6. Insert needle roller bearing, part #UKC-8154, with the integral seal A (refer to illustration) facing the gearbox side. The needle roller bearing is to be pressed into the crankshaft to the dimension shown in diagram.
