BULLETIN T-66-25

SUBJECT: BRAKE SQUEAL, TRIUMPH 1200

DATE: APRIL 7, 1966

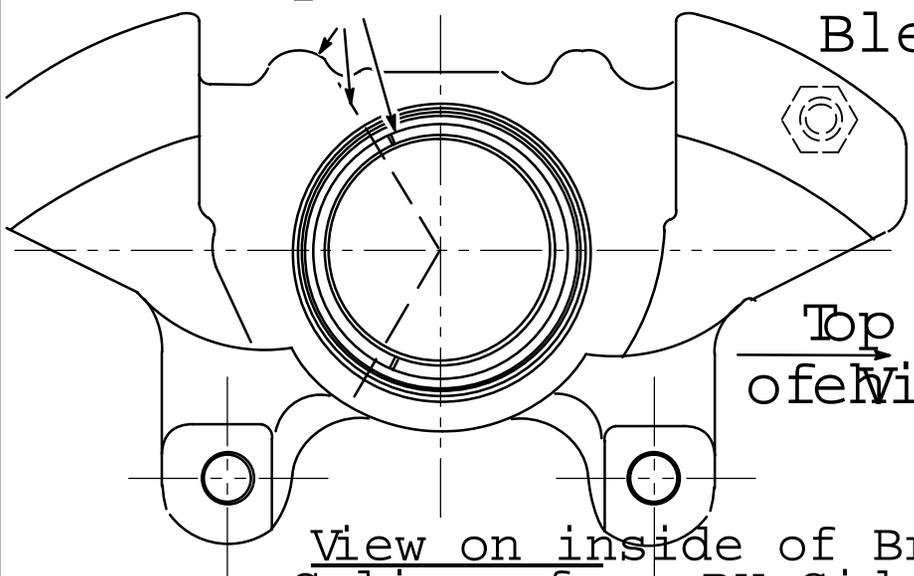
SCHEME SHOWING CALIPER PISTON AND ALSO CORRECT POSITION OF DISC PADS TO OVERCOME SQUEALING.

Piston to be positioned with the step in top position relative to casting as shown

1. Ensure that the pads are fitted correctly, with the edge "A", arrowed in the illustration, at the top of the caliper "B". This should be checked on any car, as at some earlier date, the pads may have been removed for some purpose and refitted incorrectly.
2. Whilst pads are removed, discard the claw type shim.
3. Before refitting pads, reset the four caliper pistons to bring the undercut section to the position illustrated "C".

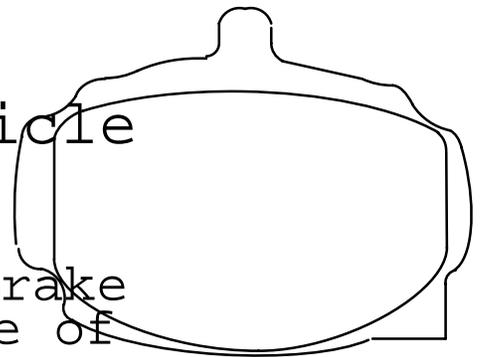
View on inside of Brake Caliper from RH Side of Vehicle

Disc pad to the Inside with the Edge on the Same Side as the Bleed Screw
