# Recall Campaign Bulletin

RECALL CAMPAIGN A442  
TR7 Accelerator Cable

1975 & 1976  
TR7'S

December, 1977

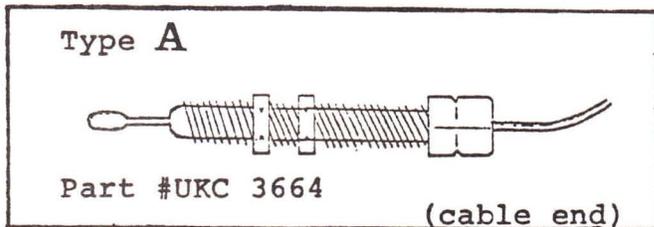
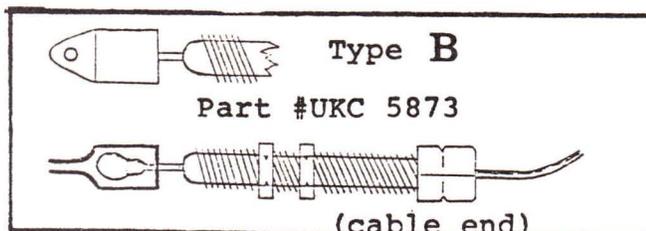
CABLE APPLICABILITY

NON AIR:

ACL 1 to ACL 21667 - A  
ACL 21668 to ACL 23620 - B

AIR COND:

ACL 1 to ACL 20409 - A  
ACL 20410 to ACL 23620 - B

1. Lift hood and locate accelerator cable. If cable is red in color the vehicle is O.K. and nothing further need be done. If cable is green in color proceed to step #2.

2. Type A cable/vehicle - remove cable from throttle link.  
Type B cable/vehicle - remove clevis pin from link at carb end.
3. Remove lock nut from adjusting thread of outer cable and remove cable from cable anchor bracket.

4. Proceed to driver side footwell and remove inner cable from accelerator rod.
5. Remove outer cable lock from firewall and remove complete cable.
6. Push new cable through firewall and lock in position.

7. Proceed to driver side footwell and hook inner cable to accelerator rod and lock in position with spring clip.
8. Route cable behind rear of engine to carbs and locate adjusting thread on anchor.

9. Type A cable/vehicle - hook cable link to carb linkage.  
Type B cable/vehicle - place clevis pin in link and replace lock pin.
10. Adjust cable to correct length and secure lock nut.
