SERVICE INFORMATION

STANDARD AND TRIUMPH VEHICLES

No.	SPORTS/2/G	STEERING COLUMN BRACING	Date	JUNE 1954
------------	------------	-------------------------	-------------	-----------

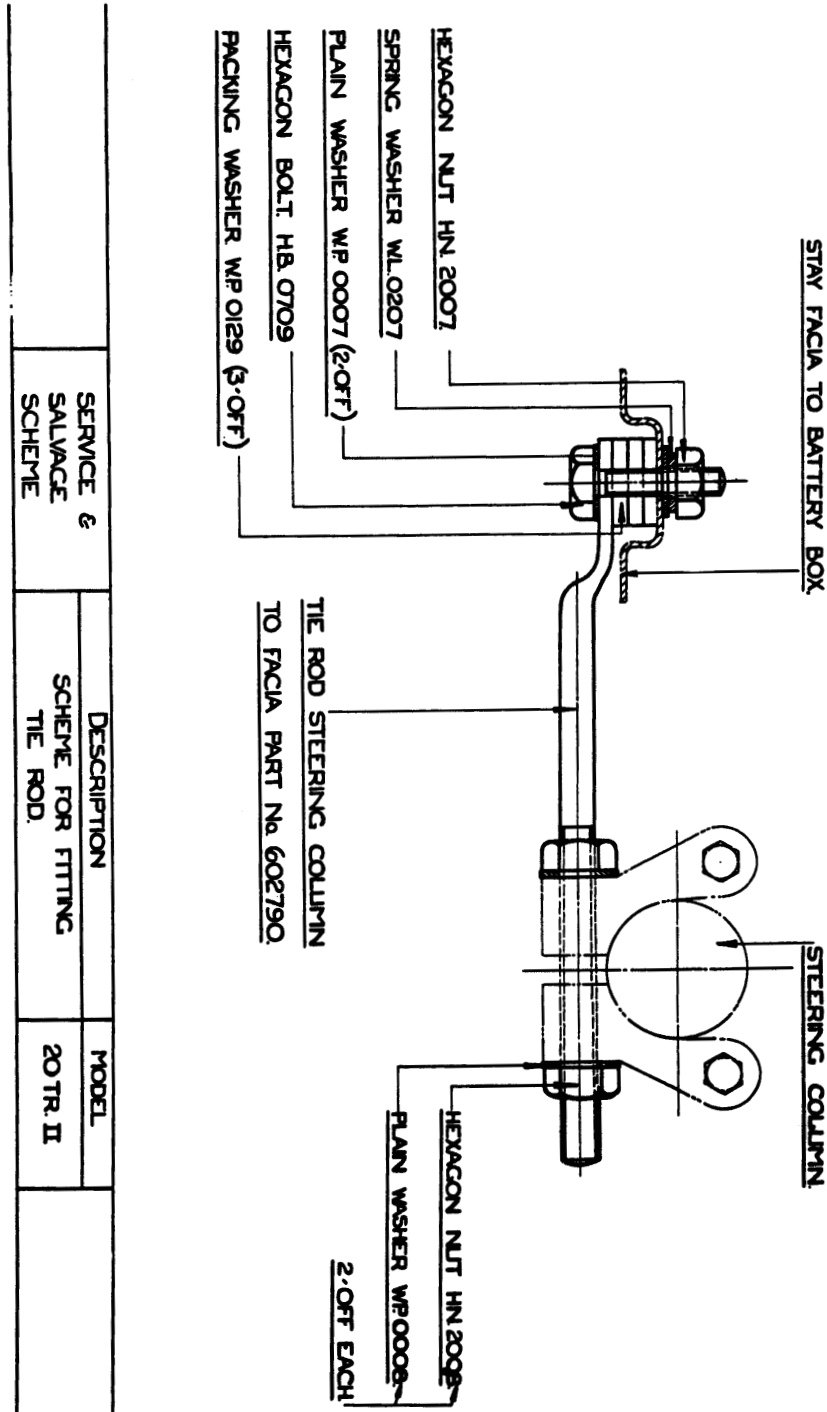
1 ILLUSTRATION.

There is a tendency with some cars of this type to develop excessive sideways movement of the steering wheel under certain road conditions.

This tendency for sideways movement of the steering wheel has been improved in normal manufacture by fitting an extra bracing strut, Part No.602790, under the facia, as shown in the illustration.

It is also proposed, as soon as practicable, to lengthen the attachment bracket from the bulkhead to permit clamping to be carried out nearer the steering wheel, but the same bracing stay, Part No. 602790, will continue to be used when this longer bracket is introduced in normal manufacture.

The extra bracing strut was introduced in normal manufacture at Commission No. TS.1390, but it may be fitted retrospectively as shown in the illustration.
