STANDARD AND TRIUMPH VEHICLES

No. SPORTS/3/B REINFORCED CAMSHAFT Date JUNE 1954

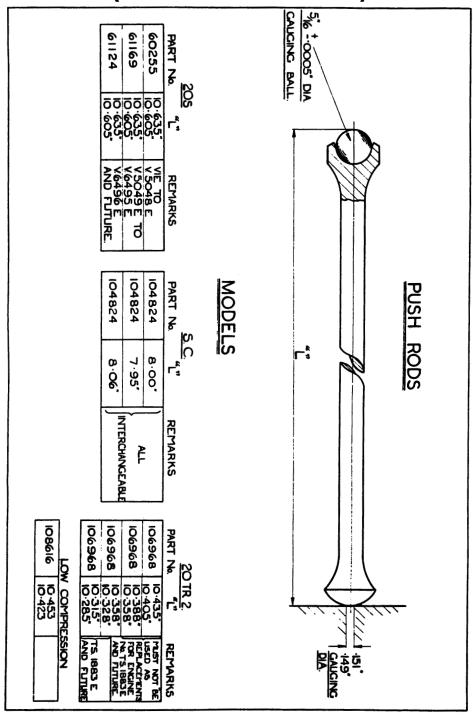
The base radius of all the cams had to be increased with this stiffening of the front section of the shaft, but the lift remains unchanged. The push rod, Part No. 106968, has been decreased in length from 10.37 inches to 10.34 inches, this dimension being measured as shown in the illustration. Although the shorter push rod is being used in production with the reinforced camshaft to provide the widest range of adjustment it is not necessary to change push rods when replacing the earlier camshaft by the modified one.

The camshaft has now been stiffened at the front section to reduce this deflection to a minimum, and this provides a greater reserve against over—revving in competition work. This reinforced camshaft, Part No. 301466, was fitted to all engines after Engine No. TS.1636E.
