TECHNICAL SERVICE BULLETIN

77-A-6

EXHAUST DOWN PIPE AND FLANGE
GASKET FAILURES

Spitfire

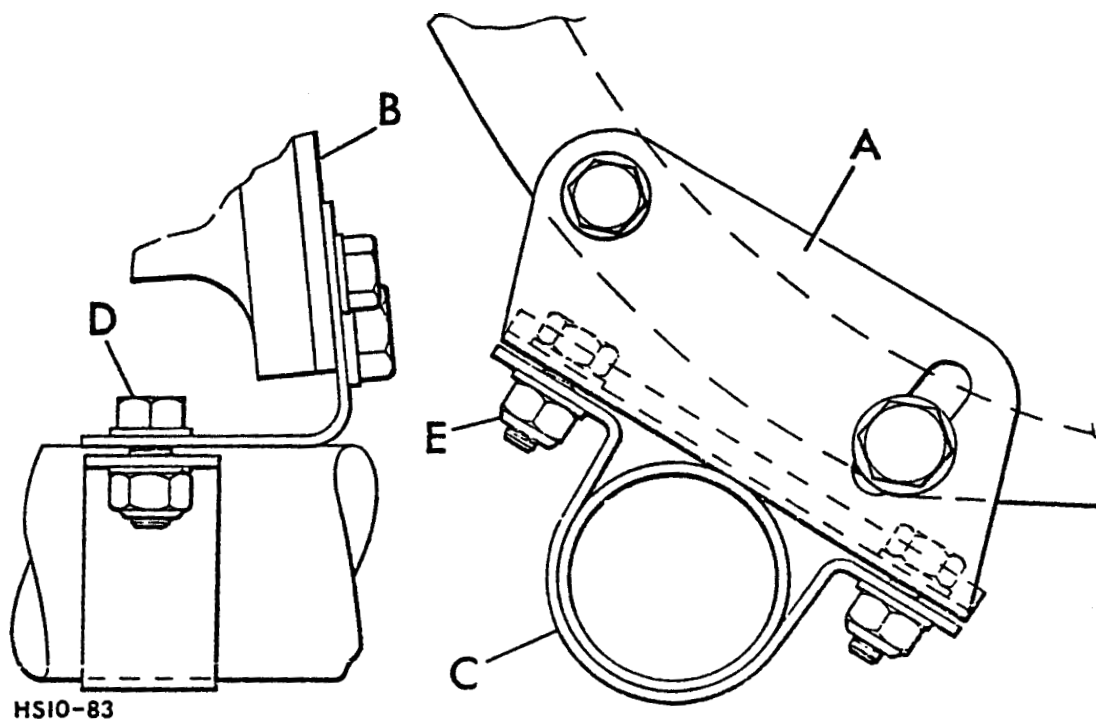
An extra support bracket and clip were introduced on production at VIN #FM-63214. The purpose of this support bracket is to prevent exhaust down pipe and/or exhaust gasket failure.

1. - Detach the support bracket "A" (part #UKC9171) to the forward side of the engine back plate "B" (as illustrated) using the two existing bolts. Do not tighten the bolts at this stage.
2. - Fit the appropriate clip "C" (part #UKC9611 or part #UKC9172) to secure the exhaust pipe to the support bracket.
3. - Tighten the clips securing bolts "D" and "E" (part #HU0806 and #143802).
4. - Tighten the support brackets securing bolts.
