# SERVICE INFORMATION

## STANDARD AND TRIUMPH VEHICLES

<b>No.</b>	SPORTS/2/B	EXCESSIVE LOSS OF OIL FROM THE CRANCASE BREATHER PIPE	<b>Date</b>	APRIL 1954
------------	------------	--	-------------	------------

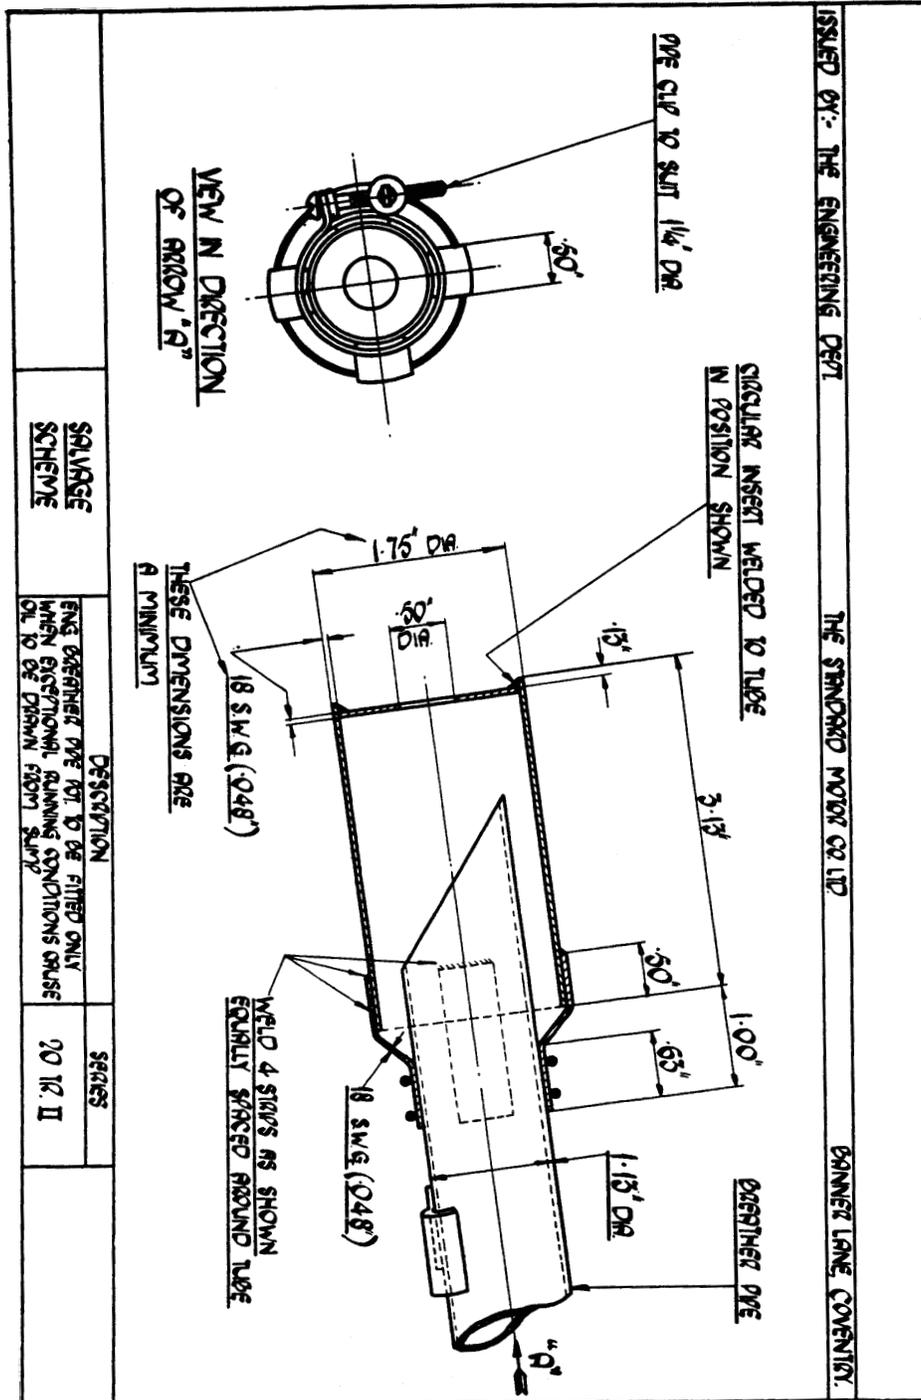
1 ILLUSTRATION.

It has been found that under sustained top speed condition that the oil splash in certain engines allows considerable loss of oil through the crankcase breather pipe, Part No. 201650.

The crankcase was modified at Commission No. TS.972E. to incorporate in the casting a baffle to shield the breather pipe aperture. A new breather pipe, Part No. 202126., must be used with the modified crankcase.

To deal with complaints of excessive loss of oil at this point, with cars prior to the Commission Number quoted, the end shield shown in the illustration can be quite easily fabricated and fitted.
