SERVICE INFORMATION

STANDARD AND TRIUMPH VEHICLES

No.	SPORTS/2/S	EXHAUST PIPE VIBRATION	Date	MAY 1956
-----	------------	------------------------	------	----------

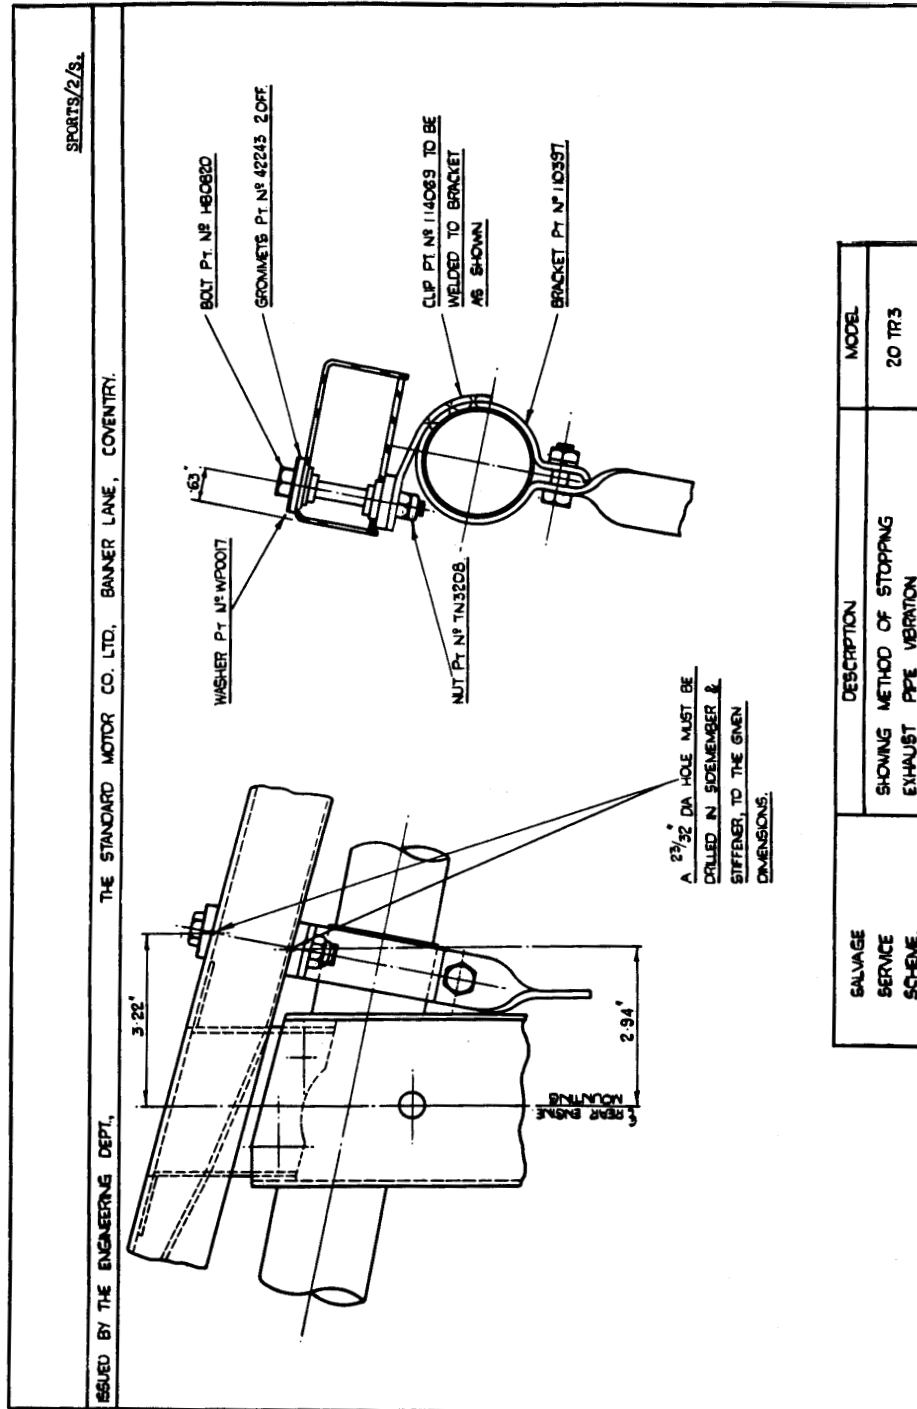
If an exhaust pipe vibration, which is not infrequently thought to be an engine vibration, is experienced at 2000-2500 r.p.m. the forward exhaust pipe mounting can be modified as shown in the illustration. The following parts are affected by this change:

1. Exhaust pipe support bracket, Part No. 110397, has been replaced by support bracket assembly, Part No. 114074.

2.	<u>Parts deleted.</u>	<u>Part No.</u>
	Flexible mounting strip.	105291
	Clamp plate.	105290
	Setscrew.	HU.0809
	Washer.	WP.0034
	Nut.	TN.3208
3.	<u>New Parts.</u>	<u>Part No.</u>
	Grommet (2 off)	42243
	Bolt (1 off)	HB.0820
	Washer (1 off)	WP.0017
	Nut (1 off)	TN.3208

It will be seen from the parts affected that the flexible mounting strip supporting the original bracket, Part.No. 110397, in a vertical plane has been deleted.

The original mounting used on the L.H. section of the cruciform, which supports the front pipe bracket, remains unchanged. The new mounting, which is an identical assembly to the latter, is used to support the R.H.S. of the bracket and is attached to the R.H. section of the cruciform.
