# SERVICE INFORMATION

## STANDARD AND TRIUMPH VEHICLES

<b>No.</b>	SPORTS/4/F	REAR HUB BEARING FAILURE	<b>Date</b>	NOVEMBER 1954
------------	------------	--------------------------	-------------	---------------

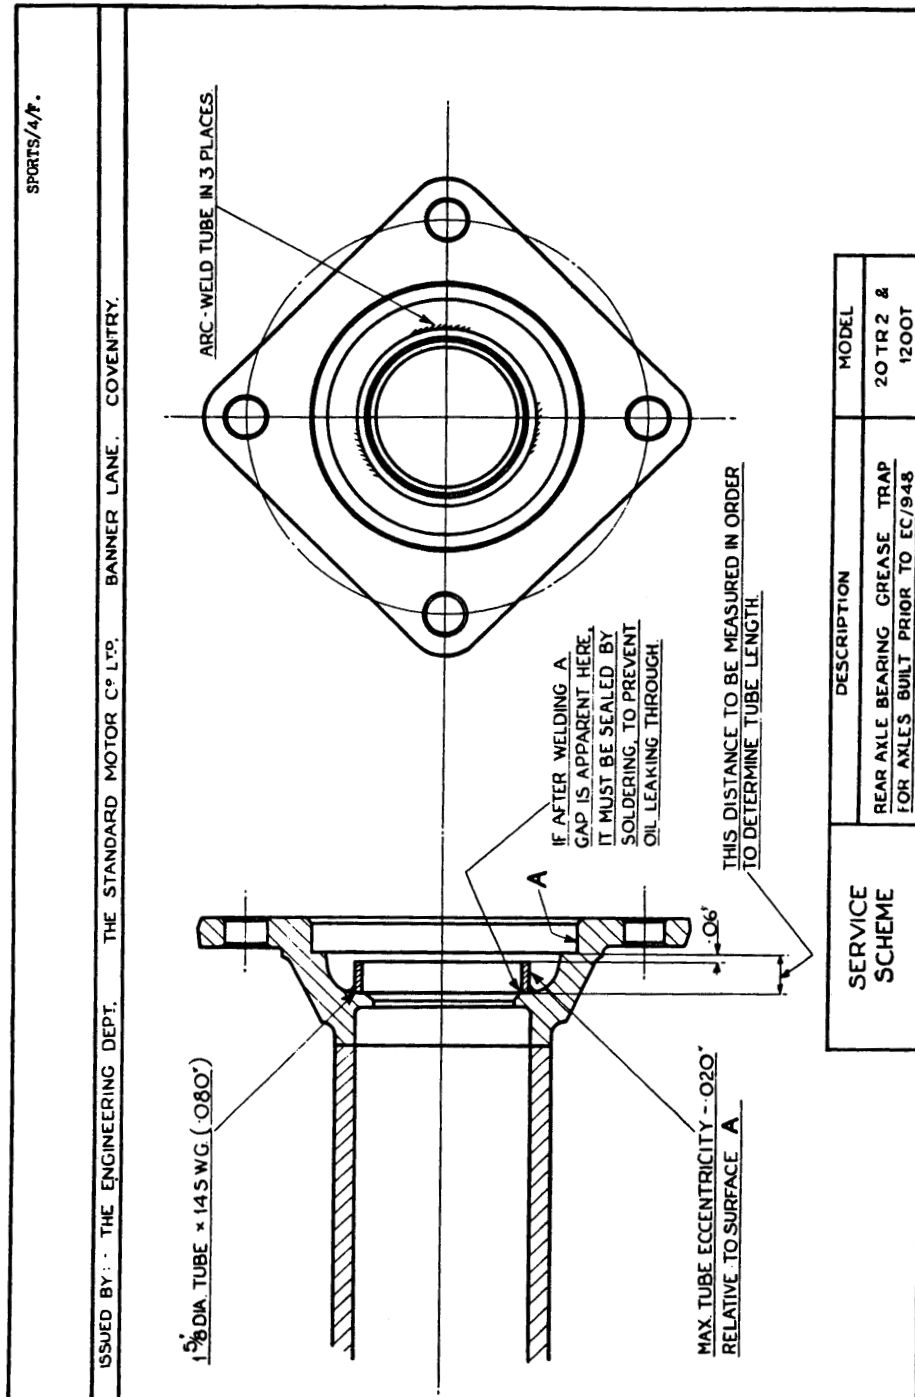
1 ILLUSTRATION.

A careful investigation has been carried out, as to a possible explanation for those failures, and we are satisfied that they have been caused by the washing action of the axle oil on the grease when cornering. This washing action has left the bearing running with only a thin film of back axle oil.

Rear axles are to be modified in normal production to incorporate a grease trap similar to that shown in the illustration. This baffle serves a double purpose, it minimises the washing effect of the axle oil on the grease and ensures that a certain amount of the lubricant is always retained under the lower lip under any conditions of cornering to which the car is likely to be subjected.

This improvement can be incorporated retrospectively by modifying the axle as shown in the illustration and such an incorporation may be considered worthwhile by owners of vehicles not so equipped, using those for Rally purposes.
