BULLETIN T-64-20

SUBJECT: TRIUMPH SPITFIRE BODY WATER LEAKS

DATE: JULY 2, 1964

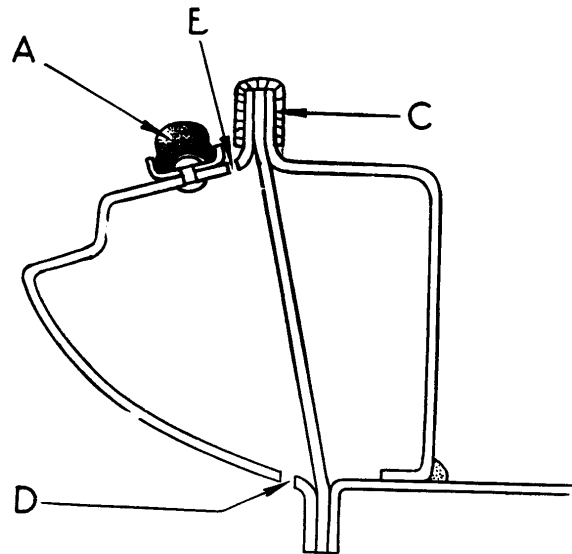
FIG 1.

8. To prevent a build up of water at the base of the door, early cars were fitted with a separate door rubber seal inserted in a channel pop-riveted to the door aperture. "A" Fig. 1. Assist the drainage by drilling three equidistant 3/16" die. holes in the top of the body sill panel in-board of the riveted channel at the bottom of the door aperture. "B" Fig. 1. To allow drainage from the body sill, a drain hole 1/4" dia. should be drilled at the rear wheel arch end of the outer sill panel at its lowest point. "C" Fig. 1

The later type of door aperture sealing rubber, part No. 707931, which combines the aperture sealing rubber and aperture flange finisher may be fitted. "D" Fig. 1. The original channel for the older type rubber should be retained as the new rubber fitted to the aperture flange will almost conceal it.
