BULLETIN T-64-41

SUBJECT: TRIUMPH TR-4 WINDOW
WINDER REGULATOR

DATE: DECEMBER 10, 1964

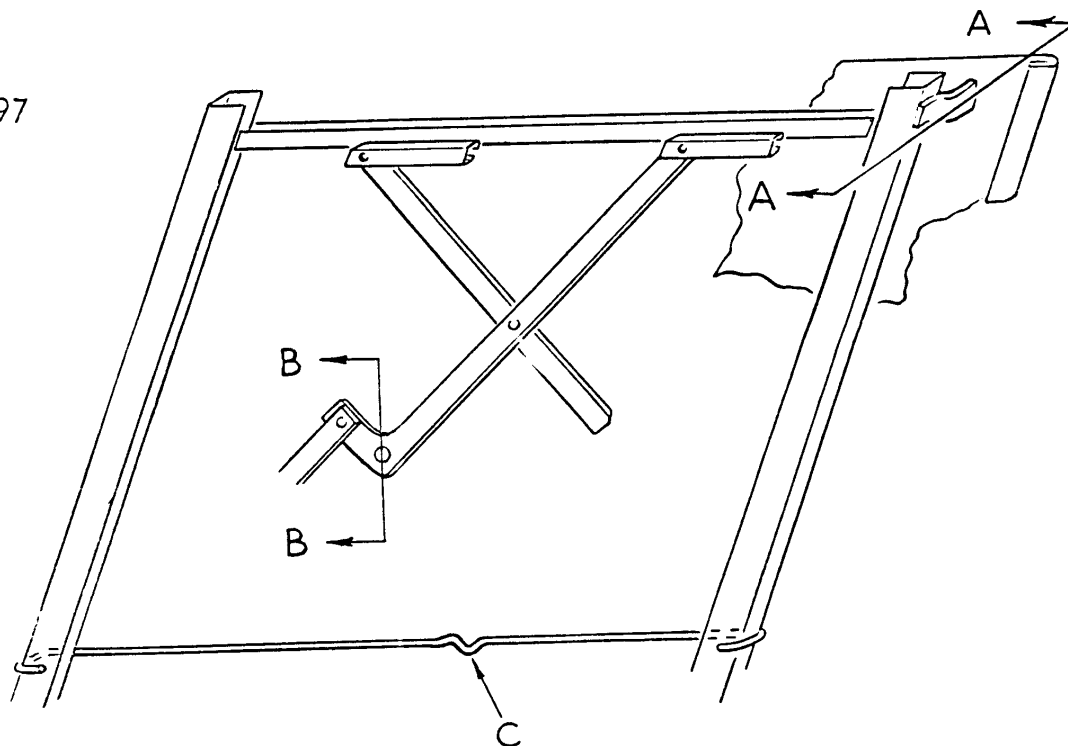
When reports of stiffness in the operation of the door glass are received, the following procedure should be adopted which will prevent straining and damage to the regulator. The same instructions should also be followed when renewing a regulator.

3. Adjust bottom brackets and crimp the tie rod to ensure that the channels are parallel (illustration C).
4. Remove regulator pivot pin nut and delete spring washer under head of nut. Add washer WP0119 1/2"x 7/8" x .050" behind head of pivot bolt and additional washer WP0160 5/16" x 1 5/8" x 16 S.W.G. behind head of nut (illustration B-B).
