SERVICE INFORMATION

STANDARD AND TRIUMPH VEHICLES

No.	SPORTS/1/B	FAILURE OF R.P.M. INDICATOR INSTRUMENT OR INNER DRIVE CABLE	Date	APRIL 1954
------------	------------	--	-------------	------------

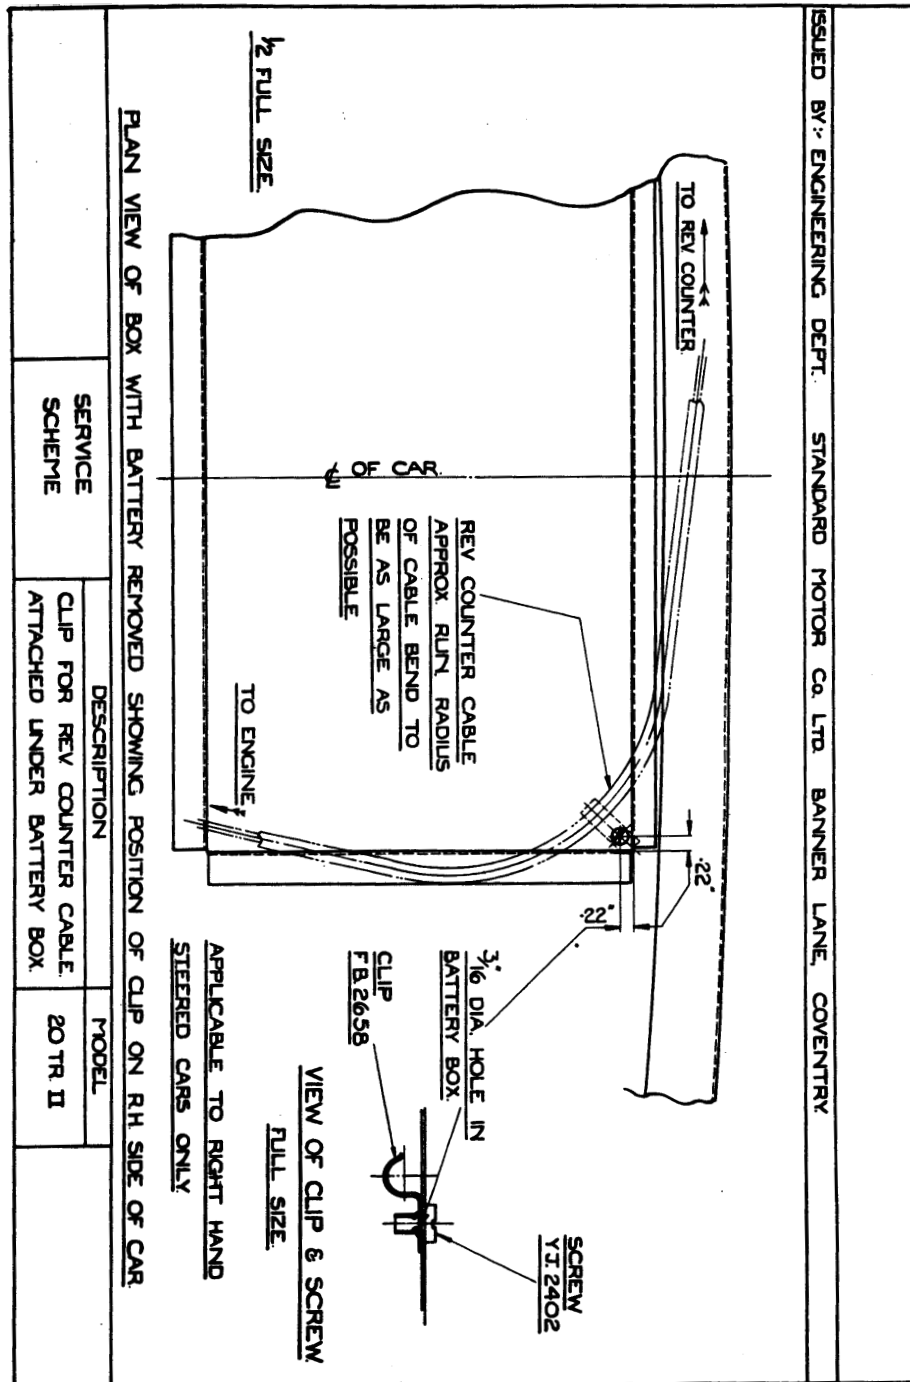
There have been cases of inner cable fracture due to sharp bends in the "run" of the outer cable on R.H.S. Models. The "run" has now been improved in factory assembly to minimise the possibility of such a condition and the modified "run" is shown in the illustration.

It is most important that both the cable for this instrument, and also that for the speedometer, are not "kinked" during installation, as once distortion of the inner cable has taken place early failure is inevitable, however correct is the subsequent run of the cable. It should be general practice to finally check the run of the cable to ensure the maximum possible radius for each bend, especially where it is "clipped" or passes through bulkheads.
