British Leyland Motors Inc.

Safety Recall Campaign A444

Recall Campaign A444 Triumph Headlamp Switch

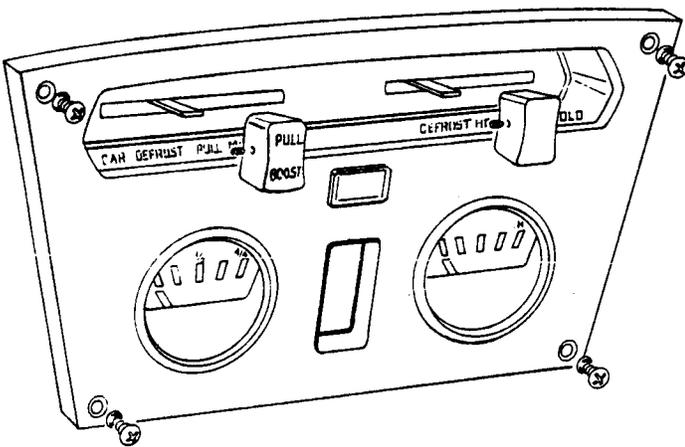
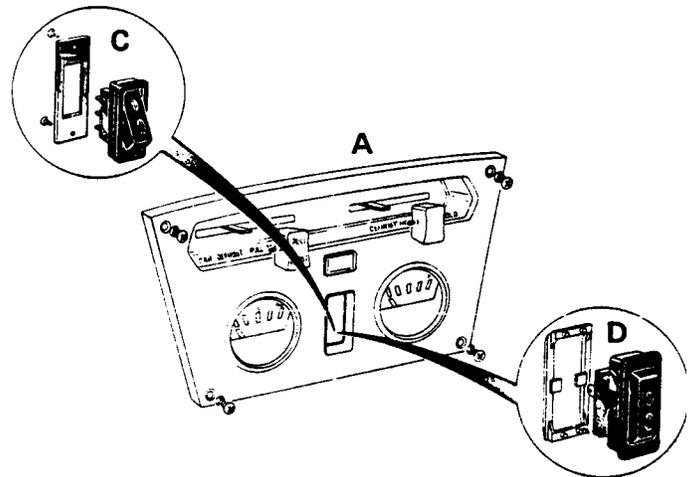
1. Remove battery ground terminal.	1. Remove battery ground terminal.
2. Remove plastic dash center panel (illustrated below).	2. Remove wood dash center panel (see illustration A below).

4. Push out existing switch from the rear of the dash panel by depressing clips.	4. Remove existing switch by removing the two small screws and retainer plate as illustrated in figure C below.

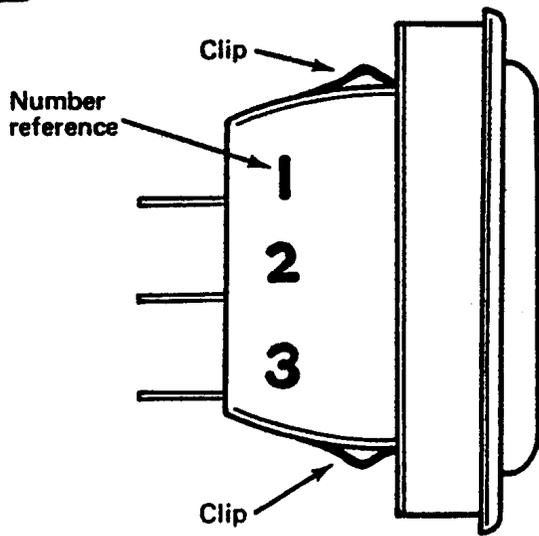
ILL. B - OLD SWITCH

3. Mark position (or make a note) of the three wires using reference on switch (1, 2 & 3) before removing each of them from the switch terminals (see illustration B).	3. Mark position (or make a note) of the three wires using reference on switch (1, 2 & 3) before removing each of them from the switch terminals (see illustration B).

1. Remove battery ground terminal.
2. Remove speedometer.
3. Remove existing switch by depressing clip (see illustration B).
4. Mark position, (or make a note) of the three wires using number reference on switch (1, 2, & 3) before removing each of them from the switch terminals. Push wires inside dash, away from opening (see illustration B).

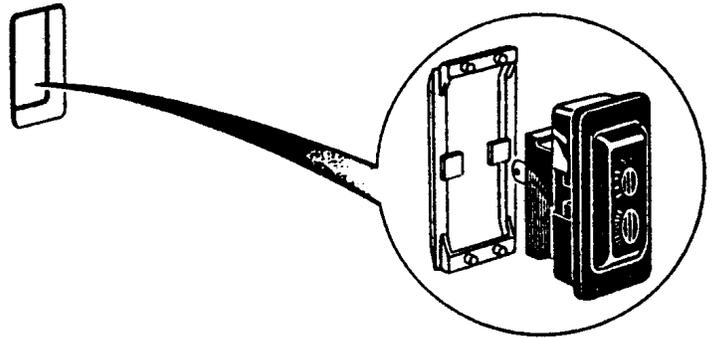
ILL. D

5. Lay dash panel face down on a clean flat surface. Using switch flange as a guide, score downwards with a sharp utility knife (see illustration C - figure 1).	5. Insert switch into dash, hold switch in position and secure retainer clip to switch as illustrated in figure D below.

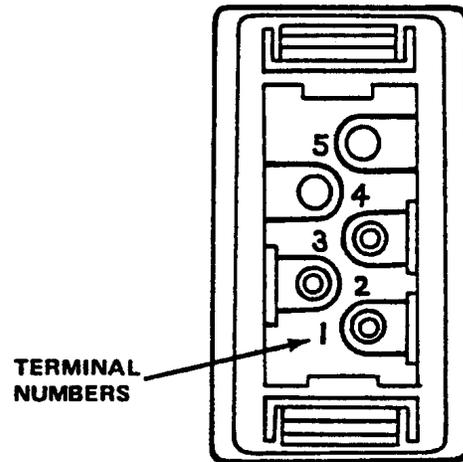
ILL. E - LUCAS SWITCH

6. Break away flange with pliers and trim opening of panel with a file, if necessary.	6. Note terminal numbers on Lucas switch. Connect wire 1 thru 3 to the corresponding terminals as in illustration E).

7. Install switch in face of dash panel and secure with Tinnerman "S" clips (see illustration C - figure 2).	7. Install wood dash center panel.
8. Note terminal numbers on Lucas switch and connect wire 1 thru 3 to the corresponding terminals (see illustration E).	8. Connect battery ground terminal and test lights. Position 1 (first click), parking lights - position 2 (second click), headlights.

CAUTION: DO NOT LOOSEN, CONTINUE TIGHTENING UNTIL TOOL BECOMES FREE IN DASH. TWO CLICKS SHOULD BE HEARD.
 - F. Remove complete tool by pushing through cut hole in dash.
6. Note terminal numbers on Lucas switch (see illustration E). Gaining access through speedometer opening, slip retainer clip on the three headlight wires, then pass wires through opening for switch. Connect wire 1 thru 3 to the corresponding terminals.
7. Insert switch into dash, hold switch in position and through speedometer opening secure retainer clip to switch (see illustration D).
8. Connect battery ground terminal and test lights. Position 1 (first click), parking lights – position 2 (second click), headlights. After test, remove battery ground terminal.
9. Install speedometer.
10. Connect battery ground terminal.
