SERVICE INFORMATION

STANDARD AND TRIUMPH VEHICLES

No. SPORTS/4/M **REV. COUNTER CABLE FOULING OVERDRIVE RELAY** **Date** DECEMBER 1954

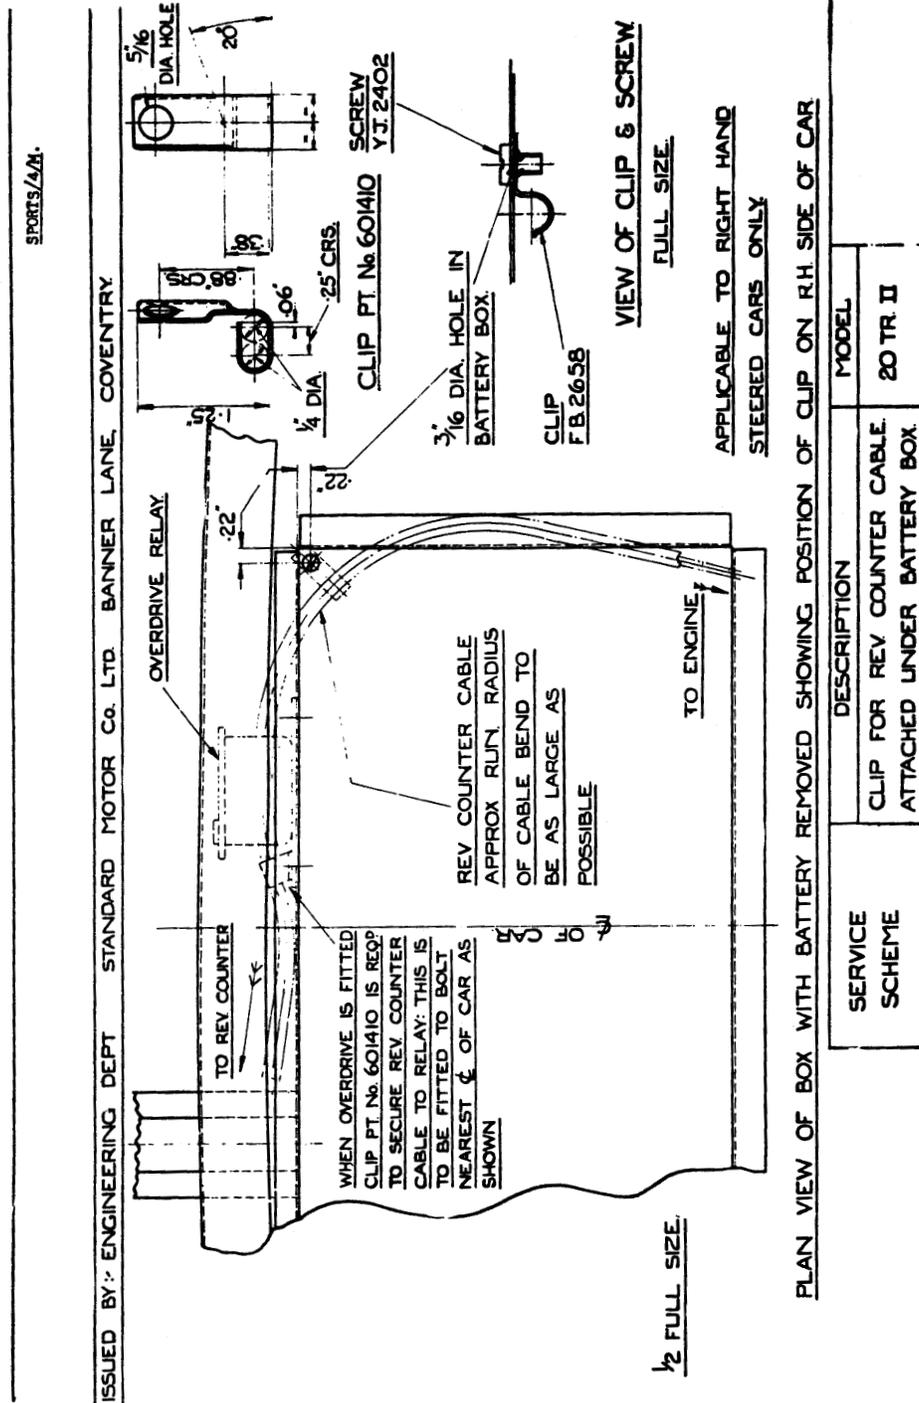
1 ILLUSTRATION.

The Rev. Counter Cable was recently lowered in order to improve its "run." In its new position the cable was brought nearer to the relay, where overdrive is fitted, and thus introduced the possibility of an electrical "short" giving overdrive on all gears.

A new Rev. Counter Cable Securing Clip, Part No. 601410, is now fitted, and located on one of the relay securing screws and positioned so as to prevent electrical contact with the relay. The correct positioning of this clip is shown in the illustration.
