## Oil cap refurbishment

Di Guy Carnegie

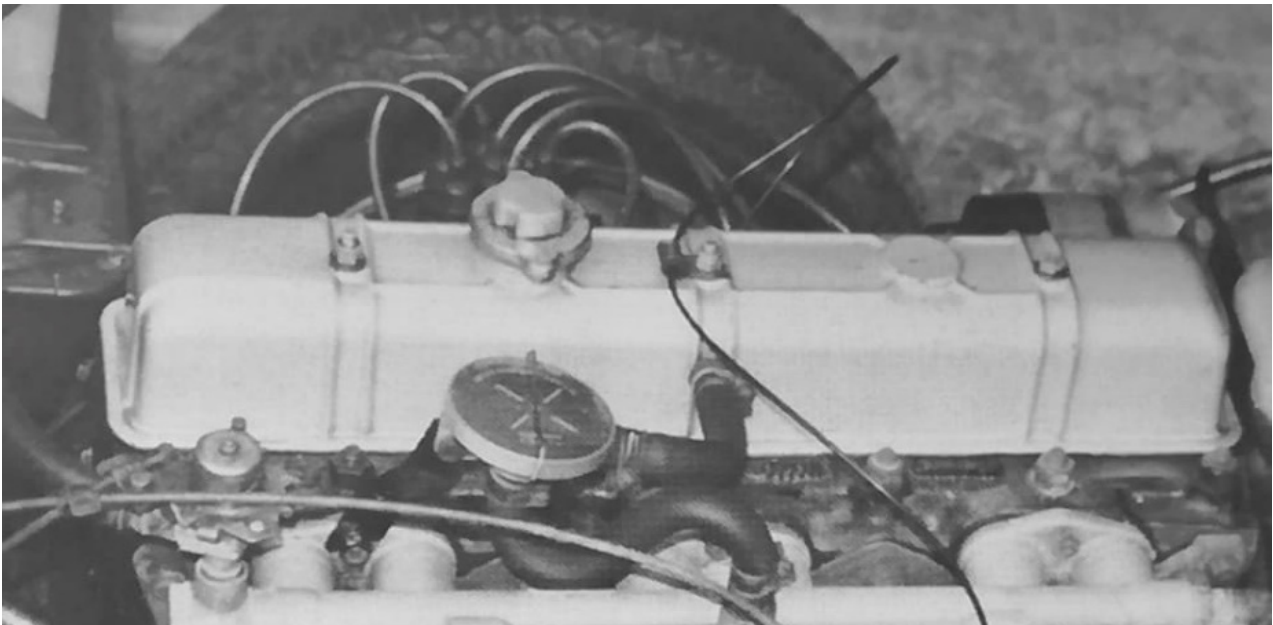
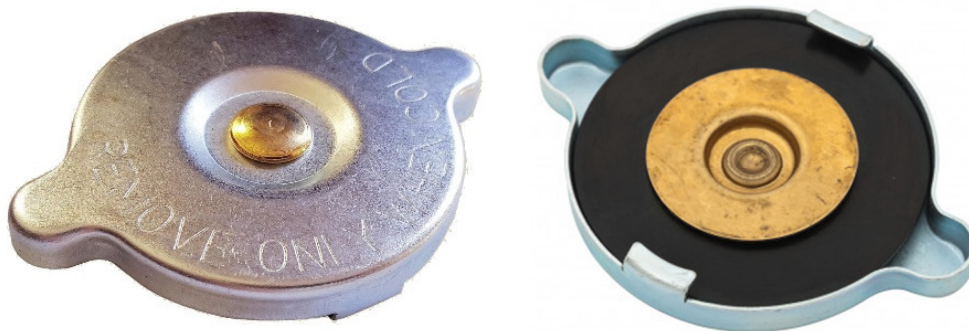
*The original oil cap, as shown in Thomason's book (above) and the currently available aftermarket part (below).*

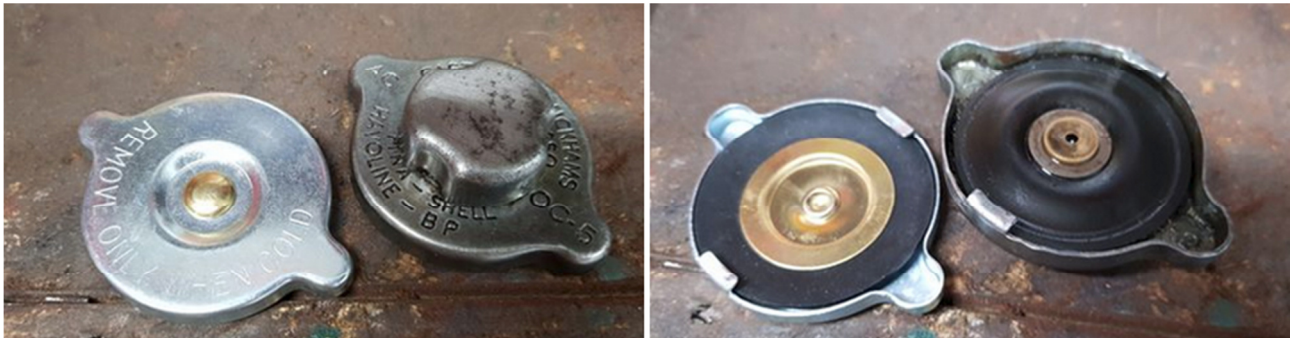
*Original versus aftermarket part.*

First off, I inspected the two caps. Not sure how exactly to get into the old cap, that part on the top looks like it might pry-off with a screwdriver.

See the leaky plastic seal on the old cap. They have slightly different designs of seals, but it looks like I should be able to swap the seal assembly over in its entirety.

If I can remove that rivet, then I should be able to swap them over.

Note that there's a vent-hole in the old-rivet which is part of the engine breather PCV System.

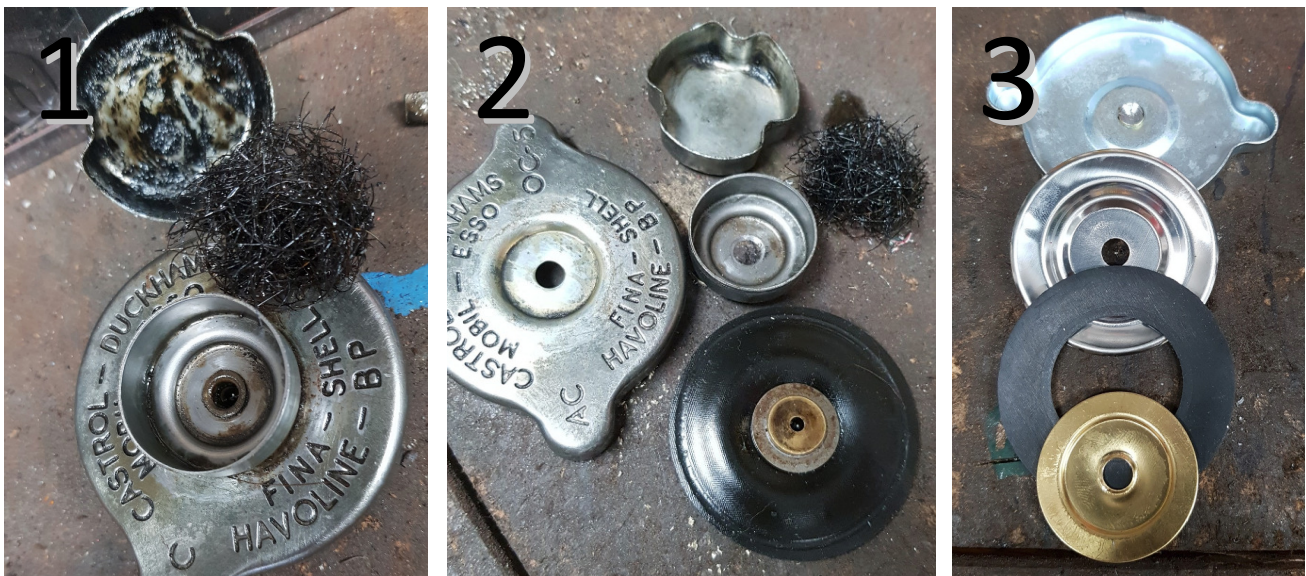
Using a flat bladed screwdriver, I was able to pry-off the top cap revealing a "horse-hair filter", and the top of the rivet.

All the parts of the old cap laid out after carefully drilling out the rivet.

All the parts of the new cap laid out after carefully drilling out that rivet.

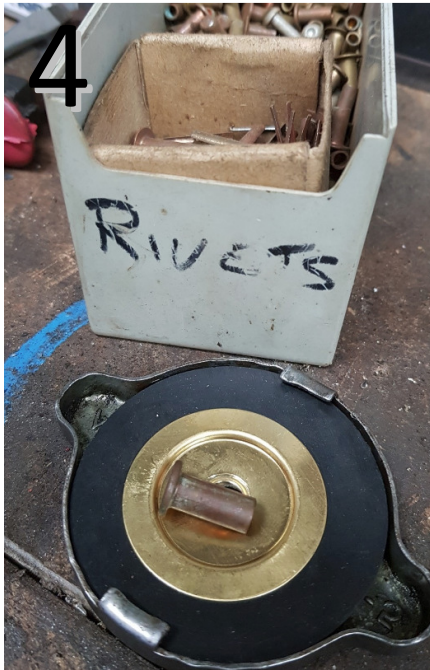
Fortunately I had a box of copper engineering rivets, and selected one of a suitable diameter – though it was a little long.

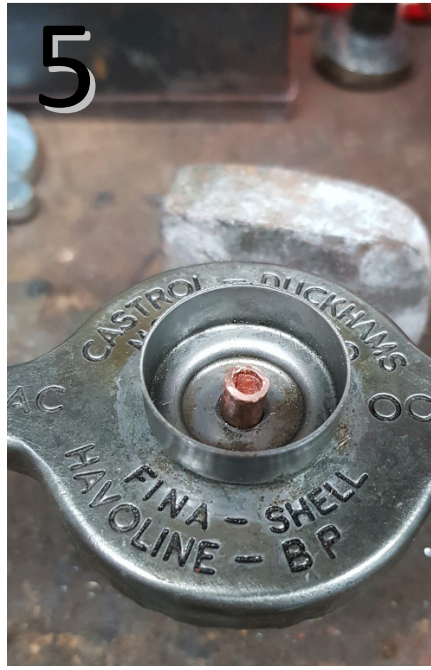
With the rivet cut down to an appropriate length, and assembled with all the parts.

I have positioned the assembly on a bodywork dolly to act as an anvil.

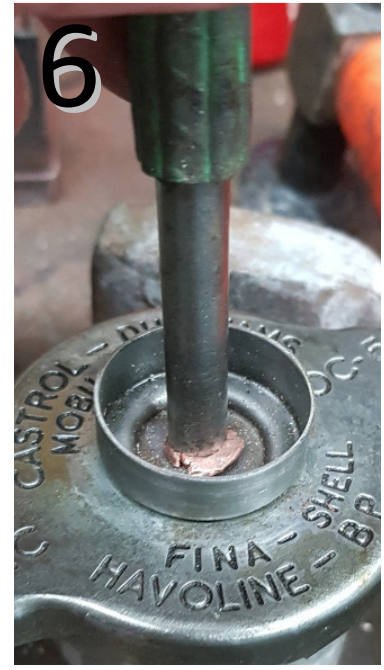
Lightly and carefully, peen-over the rivet to secure the parts together. I know proper peening punches are available, though I have used a flat-headed punch in this instance.

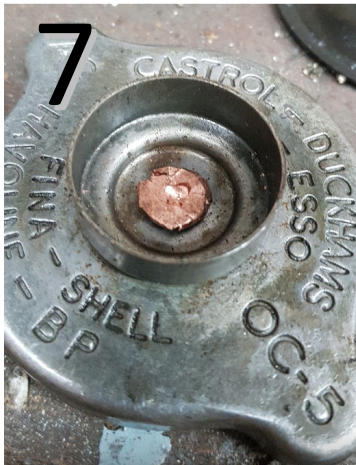
The completed rivet.

Not the best cosmetically, but functionally good.

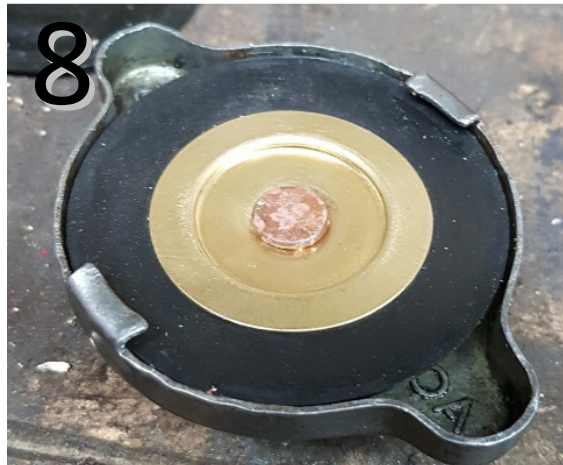
Inside shows the new seal held in place securely. At this point, I could have centrepunched and drilled a 1/8" hole through the rivet to use with the PCV breather system, though my car has no PCV so I don't bother.

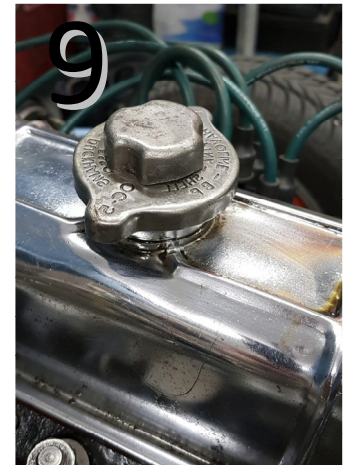
All reassembled and back on the car.
