TECHNICAL SERVICE BULLETIN

Triumph

HEAD LAMP FEED WIRE SECURITY

TR7

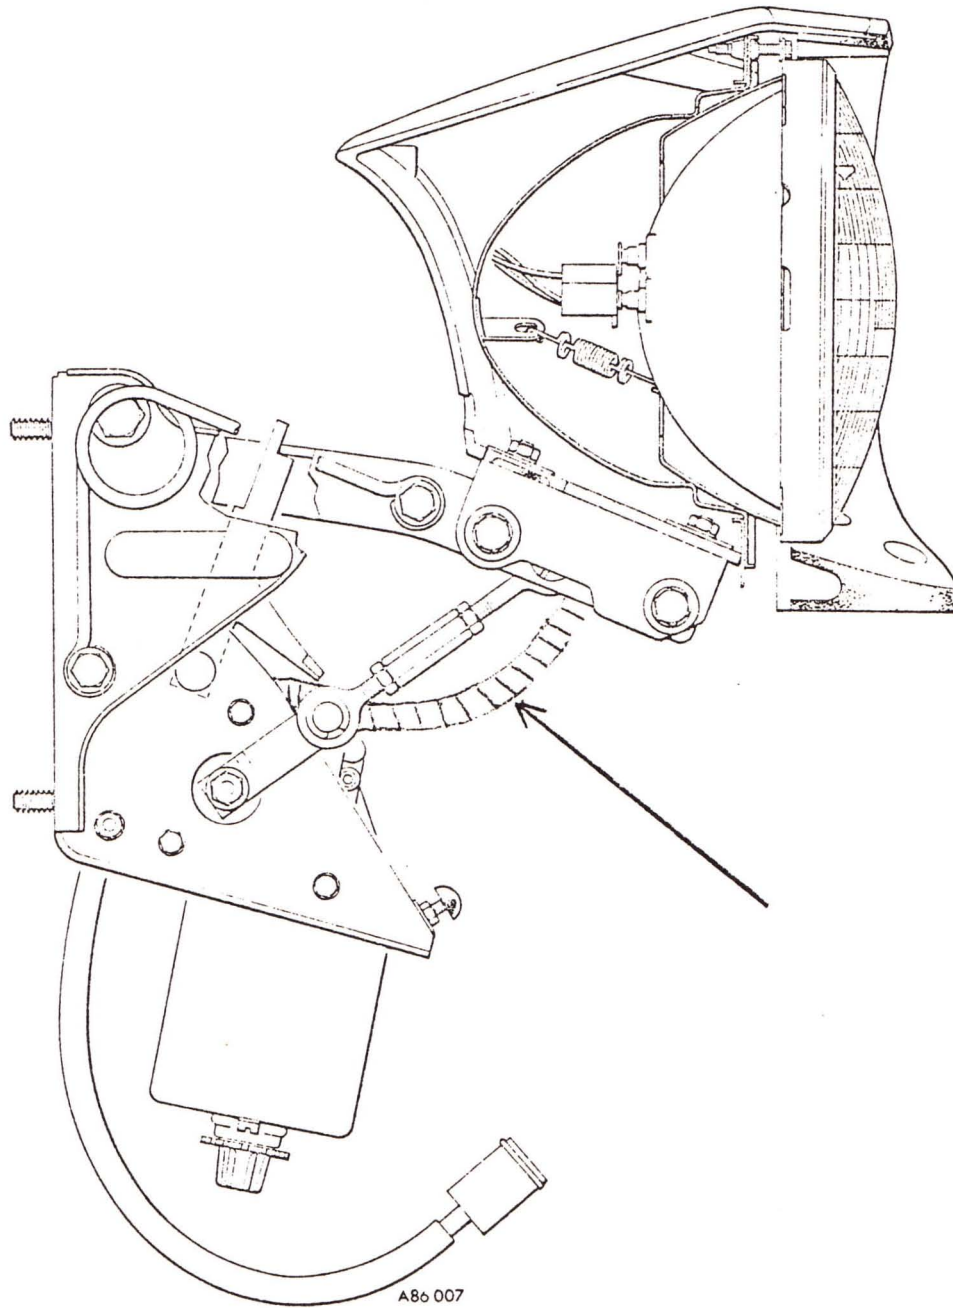
When installing head lamp assemblies on the TR7, extra care should be taken to insure that the lamp feed wire is routed in such a manner so as to prevent it from becoming trapped in the closed position, between the top of the actuating motor and the base of the lamp tray assembly (refer to diagram).
